## The retreatment of a mandibular second premolar with unusual canal anatomy

This case report is on the retreatment of a left mandibular second premolar (44) having a Vertucci's Type III canal configuration. Inability to identify this canal configuration led to a missed canal, faulty obturation and post treatment apical periodontitis.

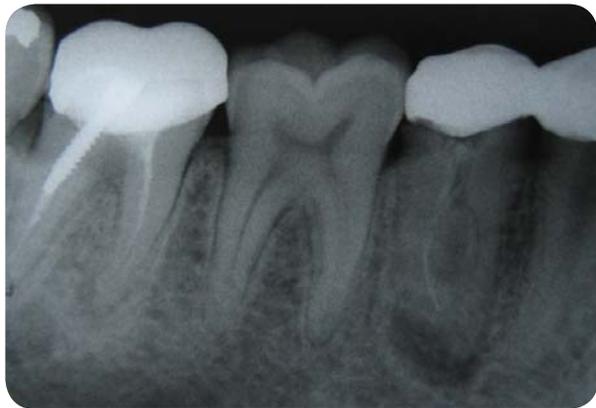
**Fig 1:** Pre operative

On clinical examination tooth 44 was rotated tender on percussion. Radiographic observation revealed a Vertucci's type III canal configuration with a missed, unobtured canal and faulty gutta percha obturation in the other canal.

These findings revealed non resolving symptomatic post treatment periapical radiolucency (endodontic failure) due to missed canal and faulty root canal treatment was made (Fig 1) and retreatment was suggested to the patient.

The full metal crown and access restoration was removed followed removal of gutta percha obturation using chemical solvent Xylene and endodontic H files (MANI, Inc. Japan). The canal system was re-entered and the missing canal was negotiated with a precurved 15 size K -file (MANI, Inc. Japan). The radiograph confirmed this negotiation and revealed a Vertucci's Type III canal configuration. The new working length was determined and the canal system was cleaned and shaped in a crown down method with Gates Glidden

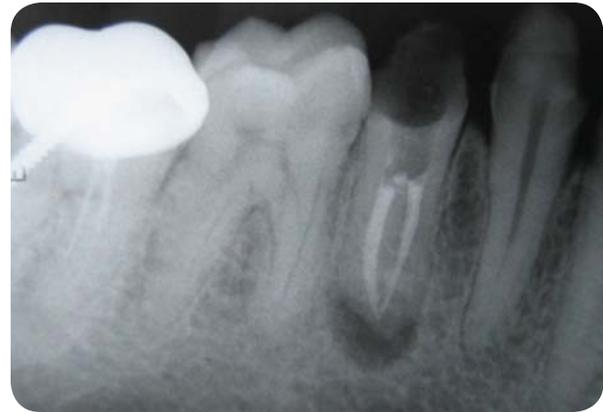
**Fig 2:** Post obturation

One week later the canal system was obturated with gutta percha and AH Plus sealer (Dentsply Maillefer, Switzerland) by lateral compaction technique (Fig 2).

The obturation was confirmed radiographically and gutta percha was removed from the coronal portion of the canal to facilitate core build up with silver amalgam (Dentsply) using corono-radicular stabilisation.

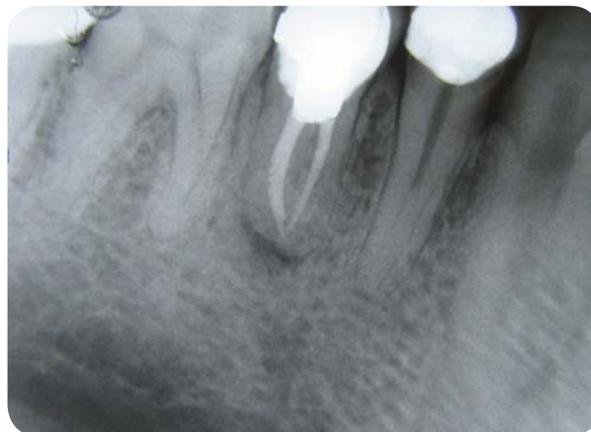
**Fig 3:** 9 months follow up

In the recall visit after nine months (Fig 3), the tooth was found asymptomatic with significant resolution of the lesion.
